**Built-Up Roofing on
Industrial Buildings
in Fife, Washington
(page 12)**

Hybrid Built-Up Roof Addresses Multiple Issues in Fife, Washington

by Traci Shaw, communications coordinator, Malarkey Roofing Products

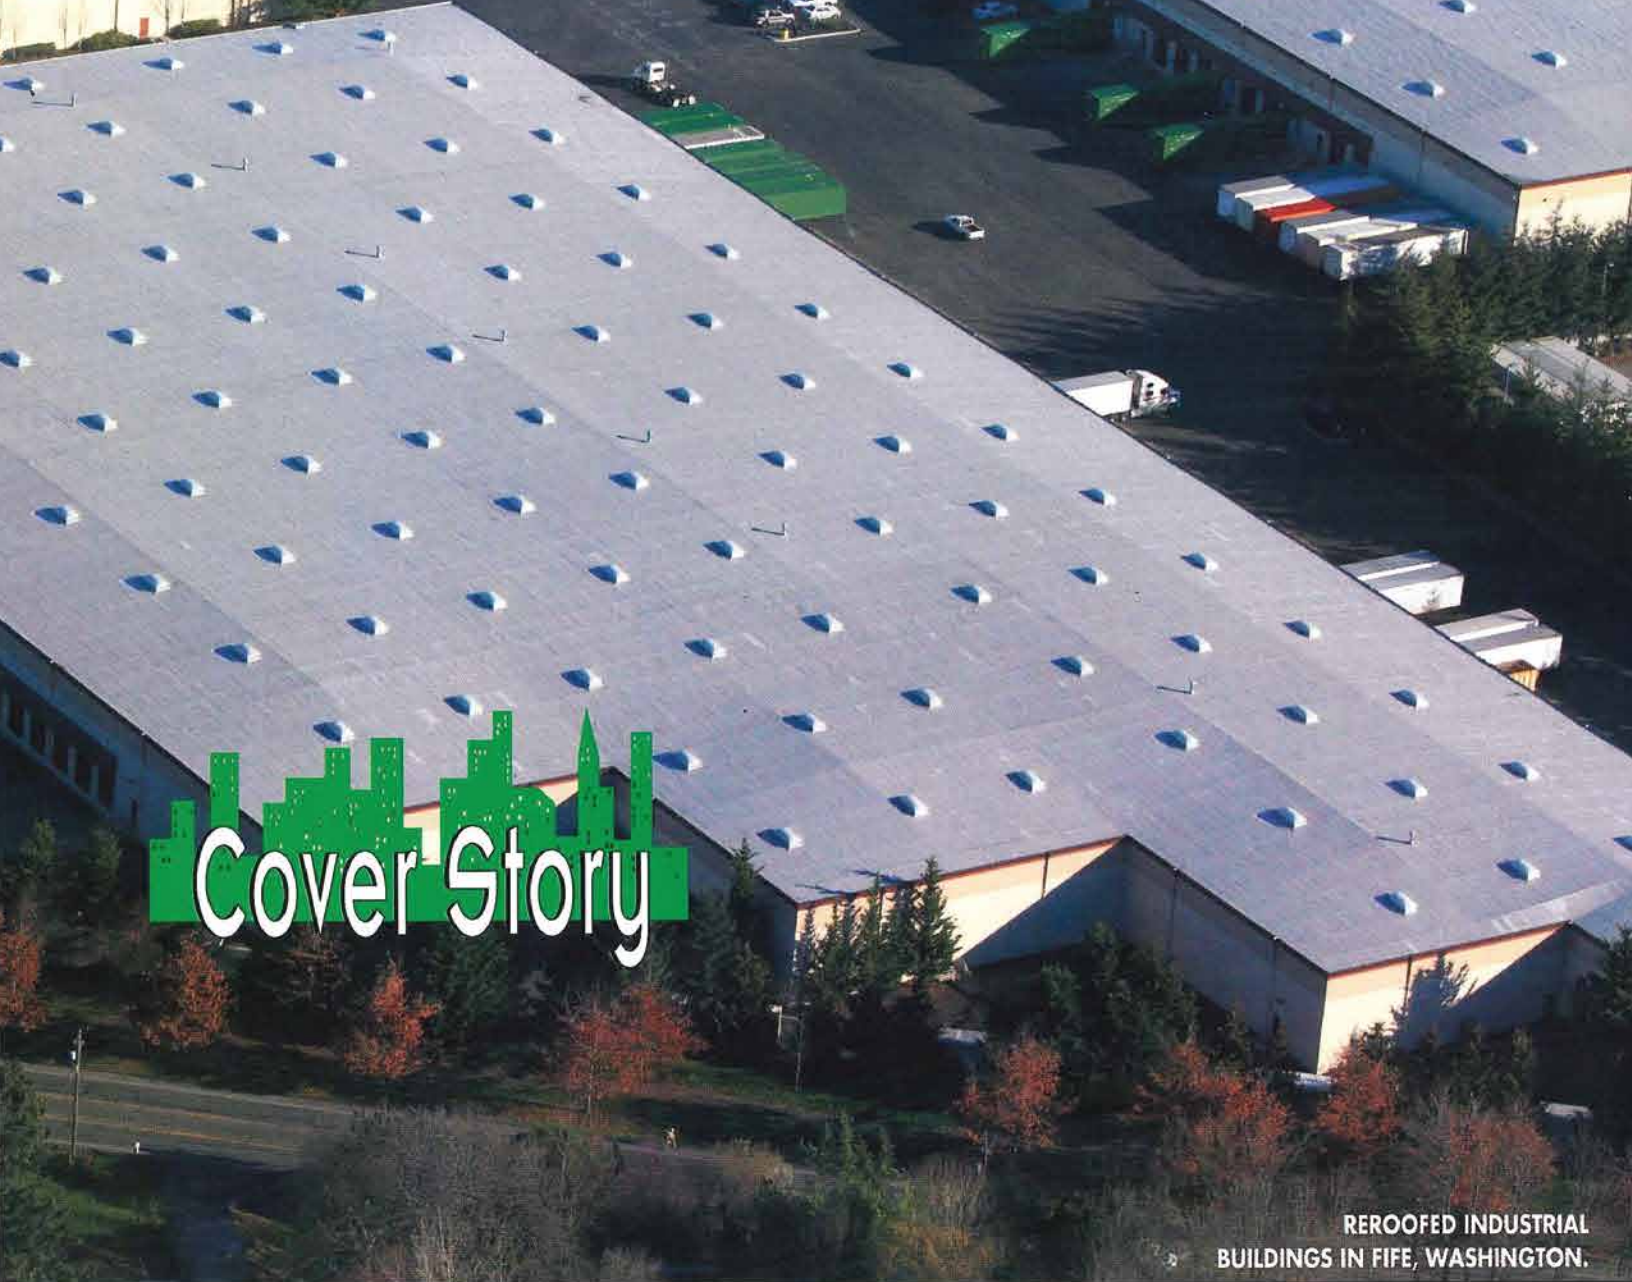
REROOFED INDUSTRIAL BUILDINGS IN FIFE, WASHINGTON.

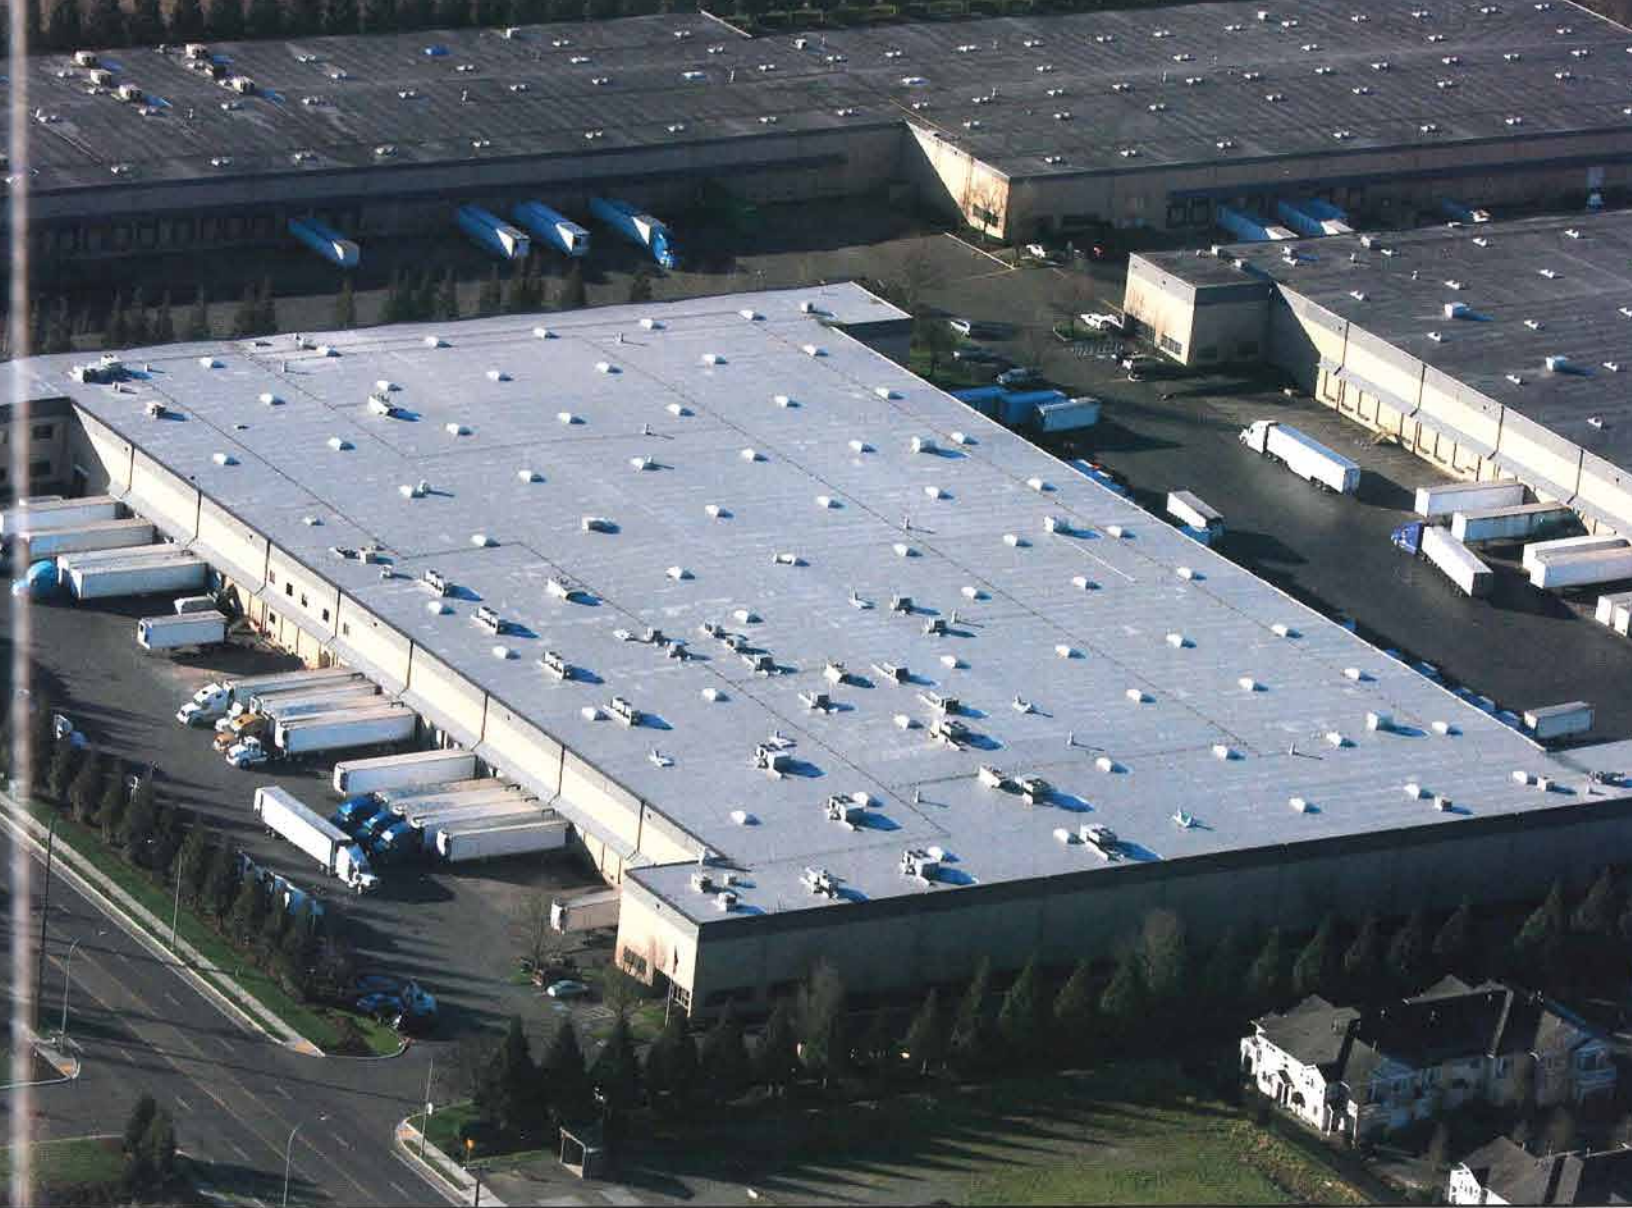
Both buildings were specified with the same roofing system, starting with a $\frac{1}{2}$ " OSB deck that was covered by $\frac{1}{2}$ " wood fiber. "Larger buildings can have a lot of movement, which can cause nails to eventually start to back out of the OSB," notes Mark Stanley of Stanley Roofing, Woodinville, Washington. "The wood fiber adds an extra layer of protection to help the roof last

longer." The wood fiber cover boards were mechanically fastened with screws and plates using 12 fasteners in the field, 15 fasteners on the perimeters, and 24 fasteners in the corners.

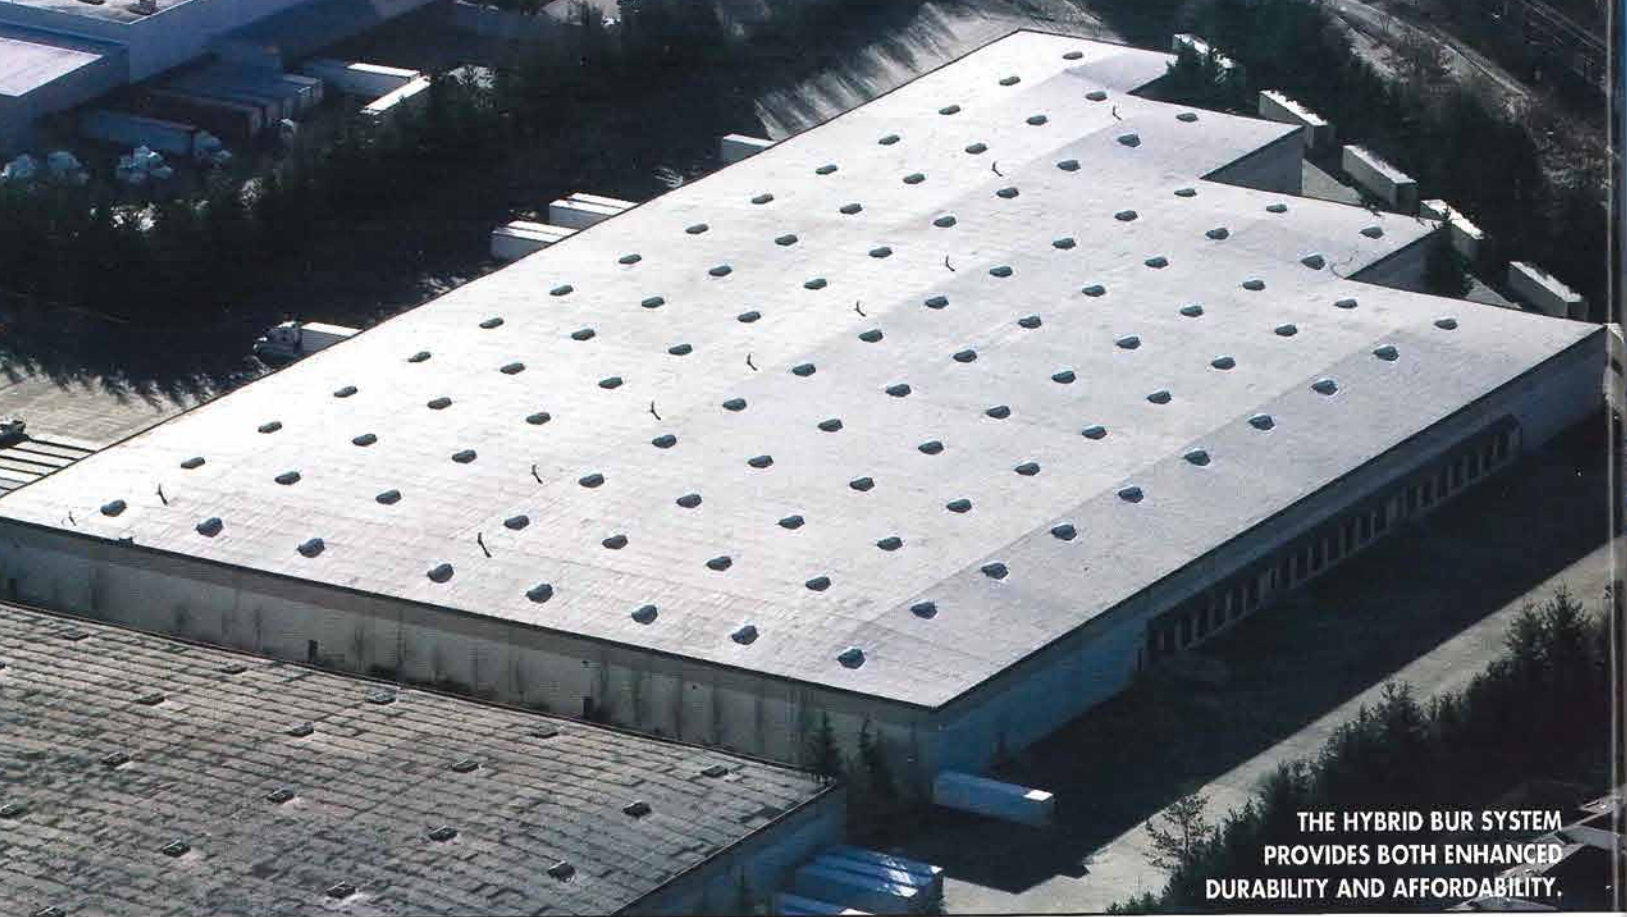
THE HYBRID BUR SYSTEM
PROVIDES BOTH ENHANCED
DURABILITY AND AFFORDABILITY.

Wetherholt and Associates specified an enhanced four-ply built-up roofing system

from Malarkey Roofing Products® for this project. "A built-up roof was chosen for the redundancy in the layers, worker safety at the roof slope, and alleviation of heavy drainage issues," notes Laurean. The system consisted of Paragon® MOD Base, two layers of Pano™ Ply 4, and Paragon MOD Cap with a granulated dove white surface. Paragon MOD Base is a 92 lb. base sheet featuring durable SBS polymer modified asphalt for added flexibility with more conformity to the substrate and resistance to wrinkling, an adaptable solution for the natural movement of large structures. Pano Ply 4 is a 38 lb. conventional asphalt ply sheet, creating a hybrid system that provides both enhanced durability and affordability to the system. Paragon MOD Cap is a 100 lb. granulated cap sheet featuring SBS polymer modified asphalt for both flexibili-

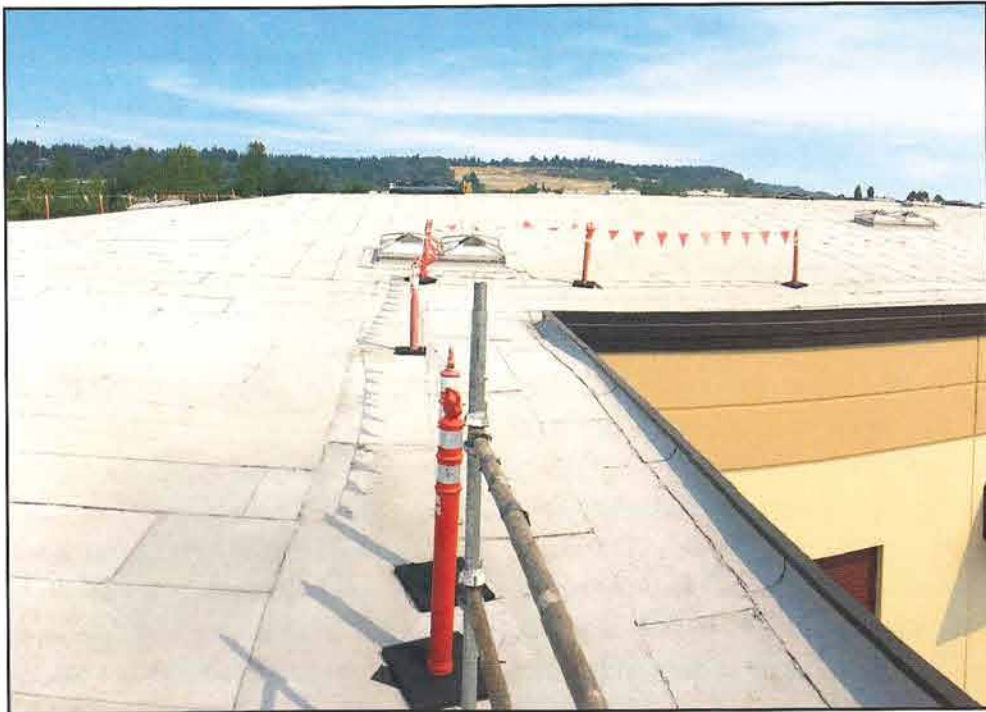
The extensive project was a successfully coordinated effort for all parties involved. “It’s definitely a task to route material delivery trucks on a project of this size,” notes Marshall Whisler of MacArthur Company, Woodinville, Washington, who supplied the materials. “We had two weeks of trucks unloading materials at the job site without disruption of business operations.” In preparation for the project, scaffolding stair-

wells were erected to allow safe, easy access to the job site for the property owners and consultants. The new roofing system took a team of 15 to 20 installers from Stanley Roofing three months to complete in the summer of 2015.
